# Are There Visual Consequences due to Greater Hood Heights of Larger Pickup Trucks and SUVs?

## ABSTRACT

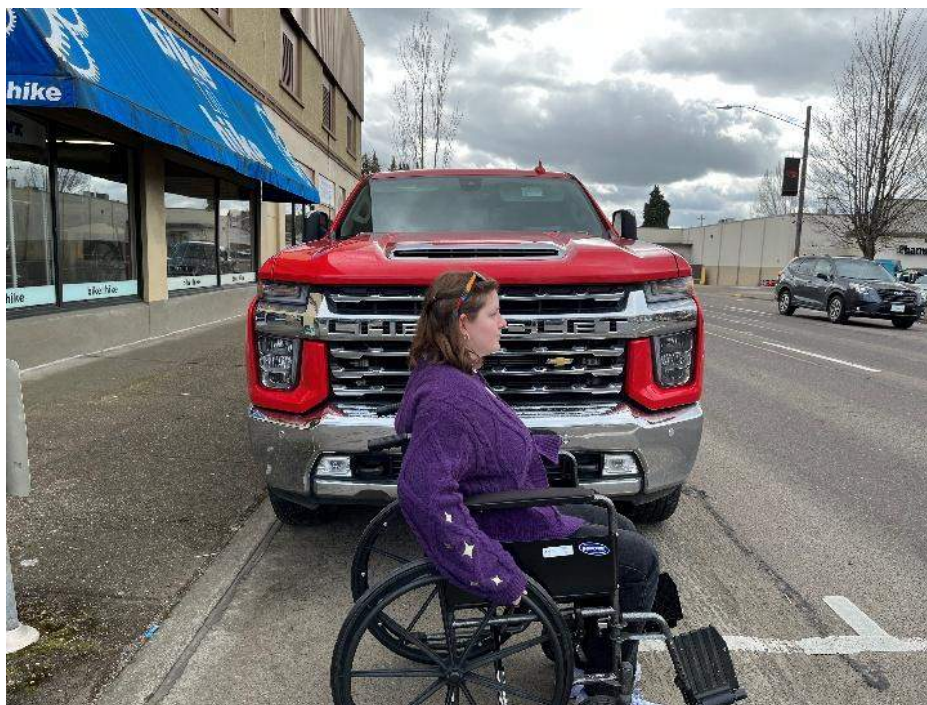
**Figure 3 Pickup Hood Height in Comparison to a Person in a Wheelchair**

Increasing hood height creates a blind spot in front of the vehicle that can occlude parts of or entire pedestrians (**Figure 2**). A child (commonly 3 to 5-feet tall) would not be visible up to six feet in front of the vehicle. By comparison an average male is about 5-foot, 9-inches (69 inches), an average female is about 5-foot, 4 inches (64 inches). The impact area where the vehicle would strike a pedestrian for the tall pickup is shown in red, while the average sedan impact area is in gold. The blind spot for the tall pickup is shown in gray. A larger pick-up truck hood is nearly higher than a person in a wheelchair (**Figure 3**).

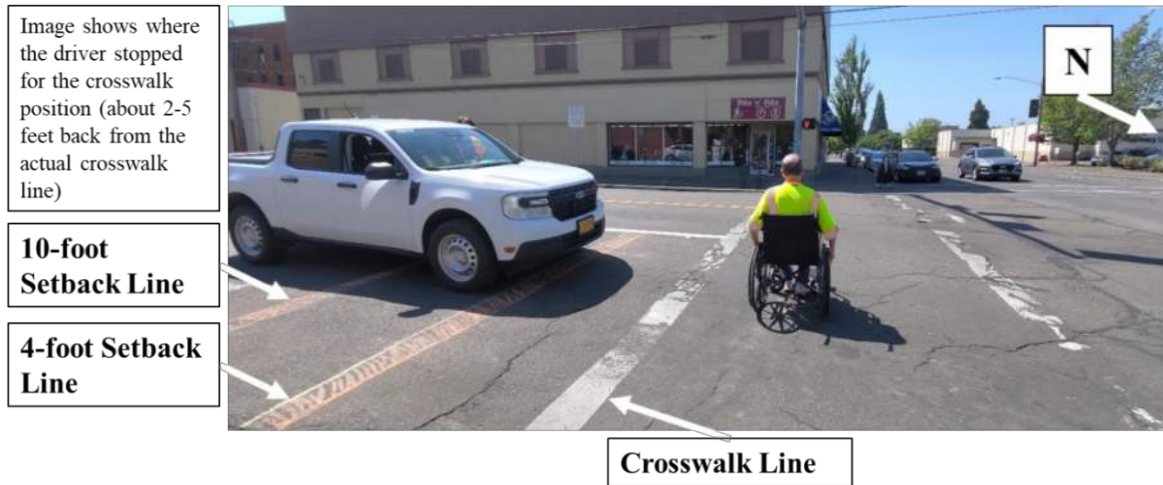
**Figure 6 In-Situ View of Test Site**

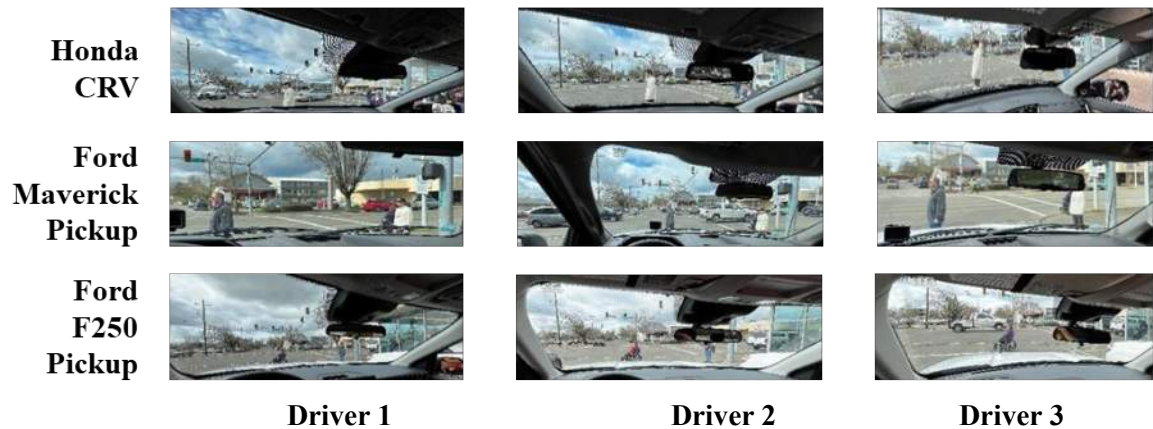
**Figure 7 Sample Image Matrix**

A series of visibility matrices were created to organize the images that were obtained to compare pedestrian visibility for each driver in each vehicle type at each stop line configuration and for each pedestrian position at the intersection. A sample matrix with the corresponding images is provided to show a few examples of the experimental variables used in the study (**Figure 7**).
