# Are There Visual Consequences due to Greater Hood Heights of Larger Pickup Trucks and SUVs?

## ABSTRACT

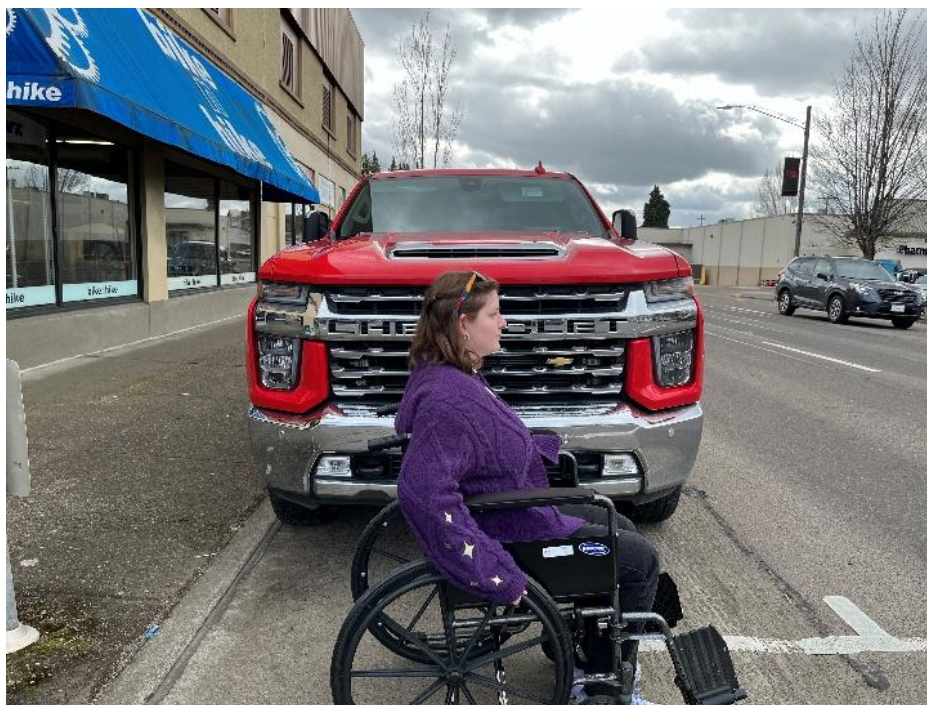
Increasing hood height creates a blind spot in front of the vehicle that can occlude parts of or entire pedestrians (**Figure 2**). A child (commonly 3 to 5-feet tall) would not be visible up to six feet in front of the vehicle. By comparison an average male is about 5-foot, 9-inches (69 inches), an average female is about 5-foot, 4 inches (64 inches). The impact area where the vehicle would strike a pedestrian for the tall pickup is shown in red, while the average sedan impact area is in gold. The blind spot for the tall pickup is shown in gray. A larger pick-up truck hood is nearly higher than a person in a wheelchair (**Figure 3**).

**Figure 3 Pickup Hood Height in Comparison to a Person in a Wheelchair**

Measurements were also taken of the person seated in the wheelchair from the pavement to the top of their head. For the people in the group this dimension varied from a low of 48-inches for the shortest person to a high of 51-inches for the tallest person. Eighteen of the vehicles noted in **Table 2** exceed 48-inches of hood height (many of the pickups and a few of the larger SUVs).

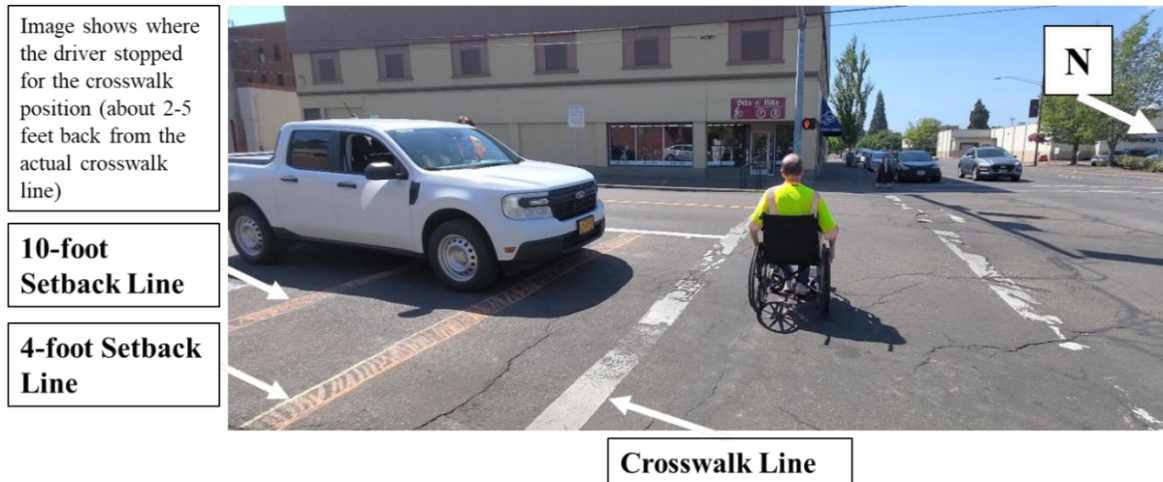
**Figure 6 In-Situ View of Test Site**

Each driver was told to adjust the position of the seat where they would be comfortable driving and placed the vehicle at different positions (**Table 4**). This always resulted in the vehicle being positioned where the bumper was setback from the crosswalk line. The eye position relative to the stop line was about 2-feet greater for the F250 than the other two vehicles. For the zero-setback vehicle position, the bumper of the vehicle was manually placed adjacent to the approach edge of the crosswalk line. For the other three vehicle positions, the driver was told to stop where they deemed appropriate, which was commonly 2 to 5 feet behind the actual setback line (**Figure 4**). Of note, each of the drivers were hesitant and stopped several times before reaching the actual crosswalk line point for the zero-setback position, as from their perspective, they felt as if they were encroaching upon the crosswalk.

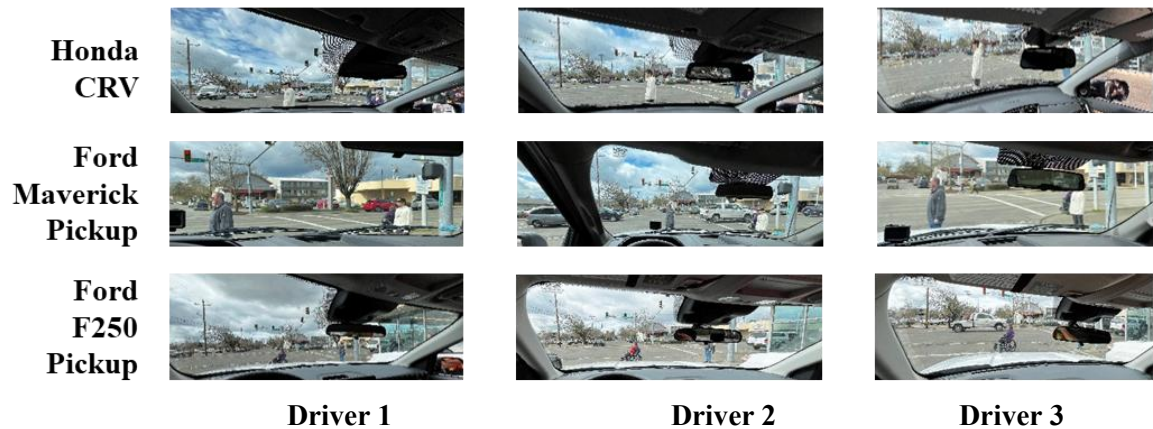
A series of visibility matrices were created to organize the images that were obtained to compare pedestrian visibility for each driver in each vehicle type at each stop line configuration and for each pedestrian position at the intersection. A sample matrix with the corresponding images is provided to show a few examples of the experimental variables used in the study (**Figure 7**).

**Figure 7 Sample Image Matrix**

From these matrices, the driver's view as captured in each picture image of each pedestrian position was analyzed independently by two researchers and grouped into six view categories. Each category was assigned a numeric rating by the researchers. The image and description of the pedestrian visibility categories were standardized (**Figure 8**). A matrix for each vehicle stop position was created. Within each image there were three pedestrian positions visible. This created a matrix for each stop line condition with 54 visibility rating entries. The inter-rater reliability measure between the two raters was 90%, indicating that they exactly agreed on 195 of the 216 unique scenario's ratings. All discrepancies were then resolved through both researchers jointly reviewing the images and agreeing on the final rating.
